Manhole Inspection Summary

Manhole # S23C1_022MH

Insp Date: **7/7/08 8:30 AM**

Location Address: **2420 Puget St** Cross Street: **Holland Ferry Rd**

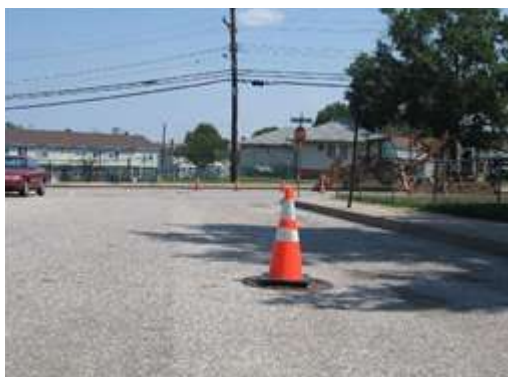
Misc

Manhole Type: **Inline** Location: **Roadway** Ground Conditions: **Dry**
☐ Prev. Rehab Weather: **Dry** Subject To Ponding: **None**
Comments **Sticks stuffed behind rungs require flatbed crew while other debris could be addressed by vactor.**
